Case Studies

As the validation of the designed product in real cases is a crucial aspect to be taken into account to ensure the reliability of the product, following real four cases has been selected for the project, representing European, and African Mediterranean Heritage.

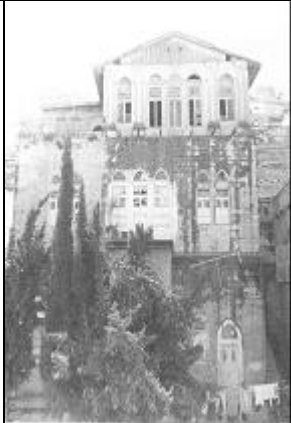
DOA	Jordan SITE2	Palace of King Abdullah I in Ma'an. It was built between 1904-1908 AD. It is a rectangular building consisting of a basement and two floors above. The foundations are of stone and they are a continuation of the interior and exterior load bearing walls. These walls are built of regular ashlar along their exterior faces and rubble stones along the interiors with mud mortar to bind the stones together. Wood is the main element used in the roof structure, tied together in a truss form.

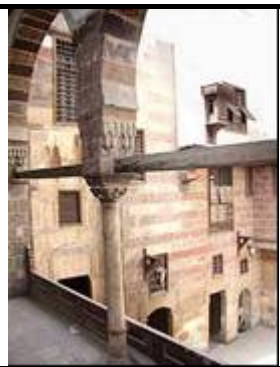
SCA	Egypt SITE3	Brick building. Monument of several floors built with adobe bricks. Gammal house was an initially established case study but, nowadays, a new one will be selected when project starts, accordingly with SCA and ECAE.
